November 29, 2005

Mr. Tony Westrich
Ultrafryer Systems
P.O. Box 5369
San Antonio, TX 78201

Re: Heat Exchanger Weld Evaluation

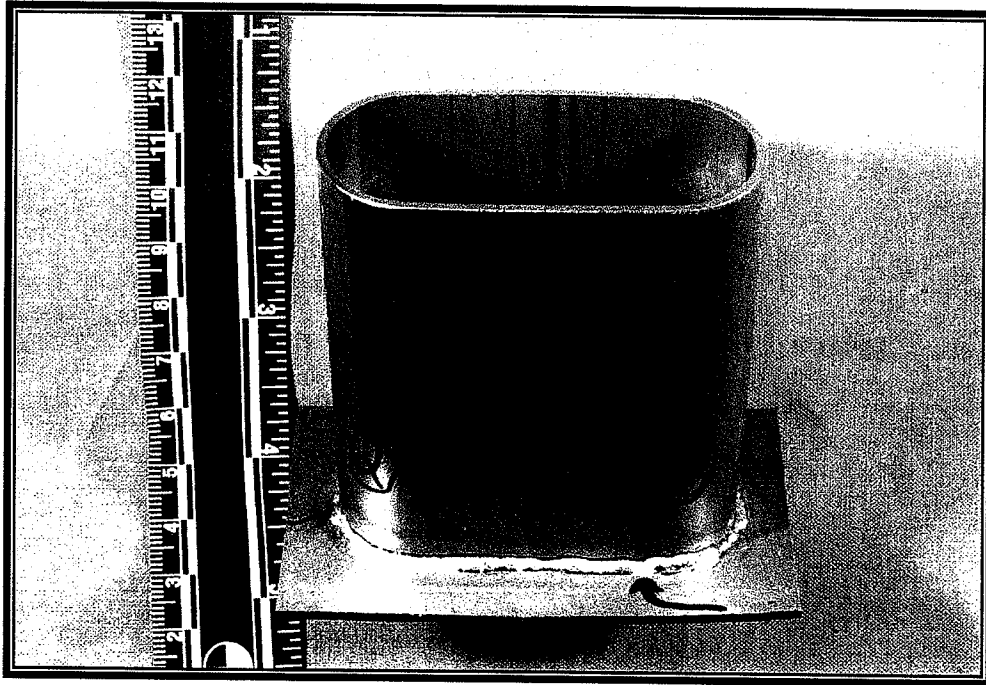
Figure 1 – Typical weld specimen after separating the test sample into sections.

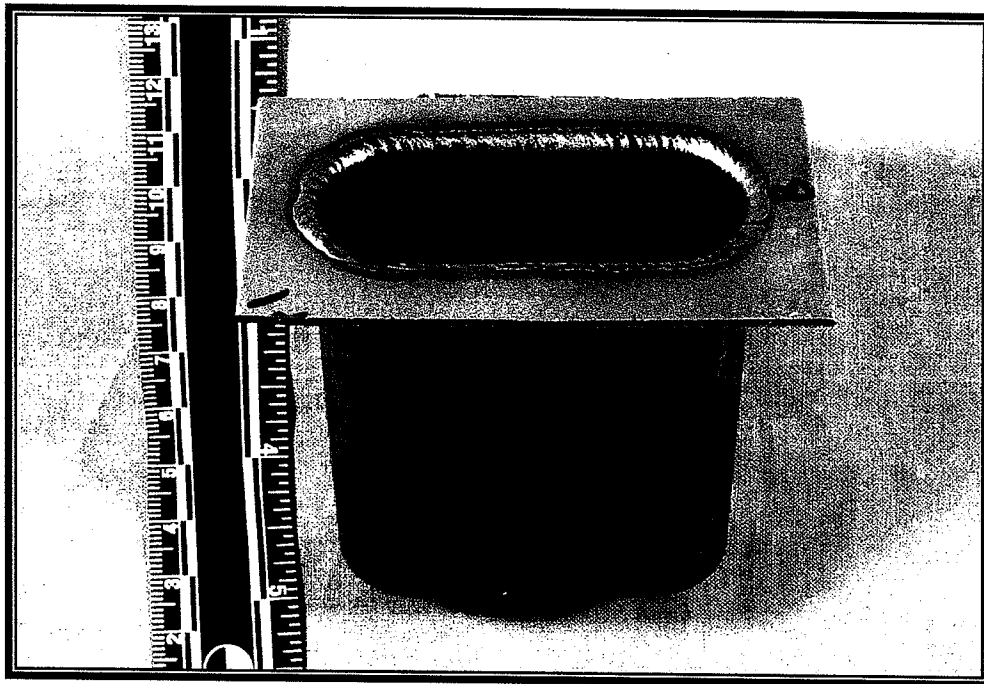
Figure 2 – Welding side of the tube-to-sheet joint.

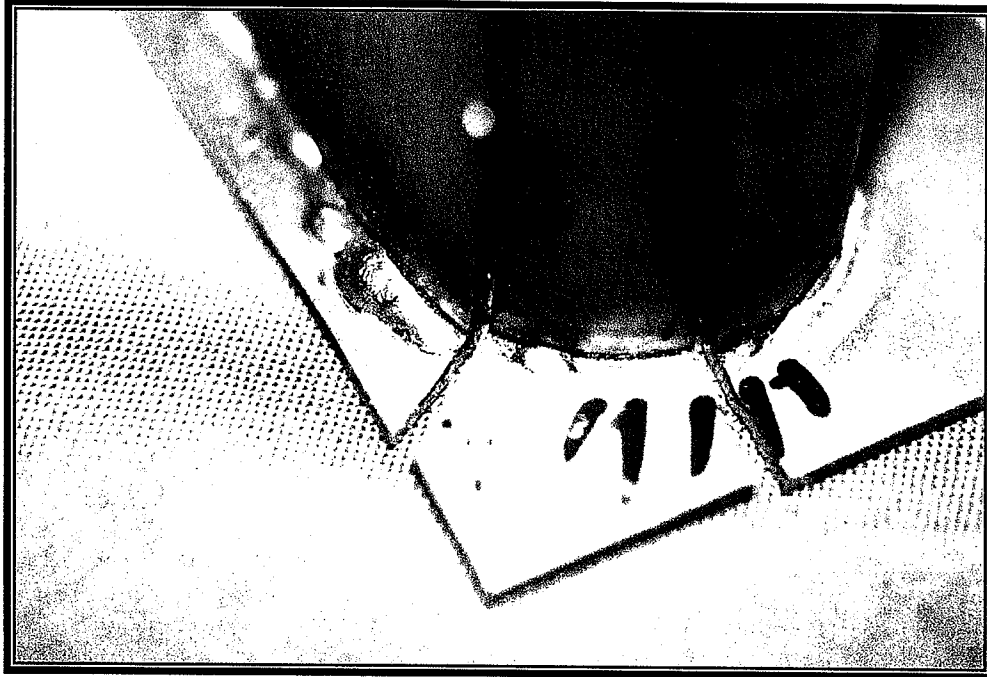
Figure 3 – The weld in specimen IIC, quadrant three.

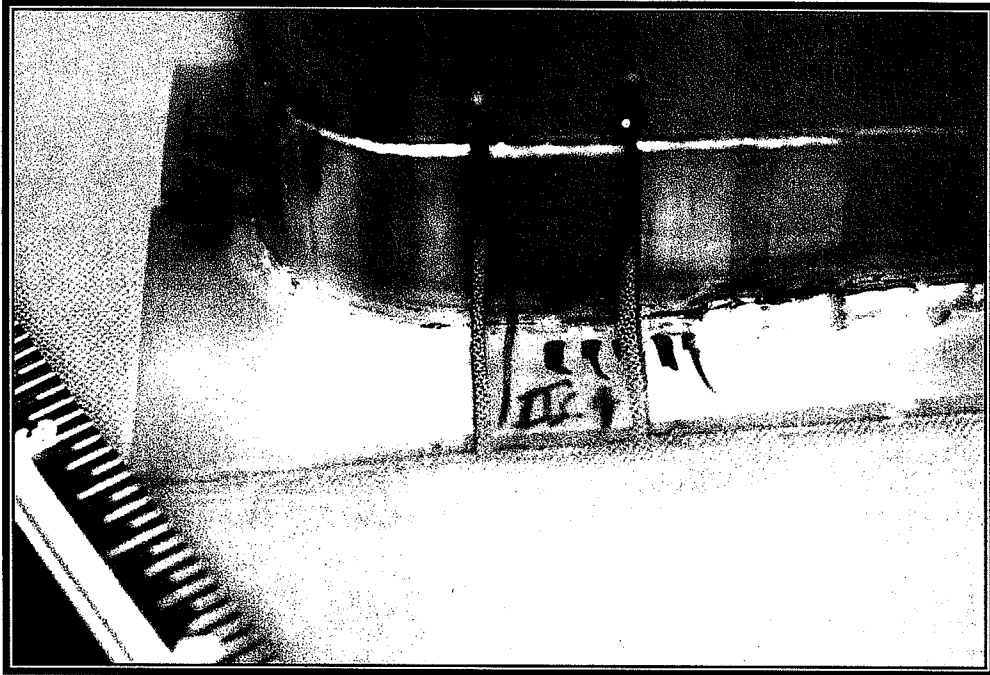
Figure 5 – The weld in specimen IIC, quadrant four, was cross sectioned for examination.

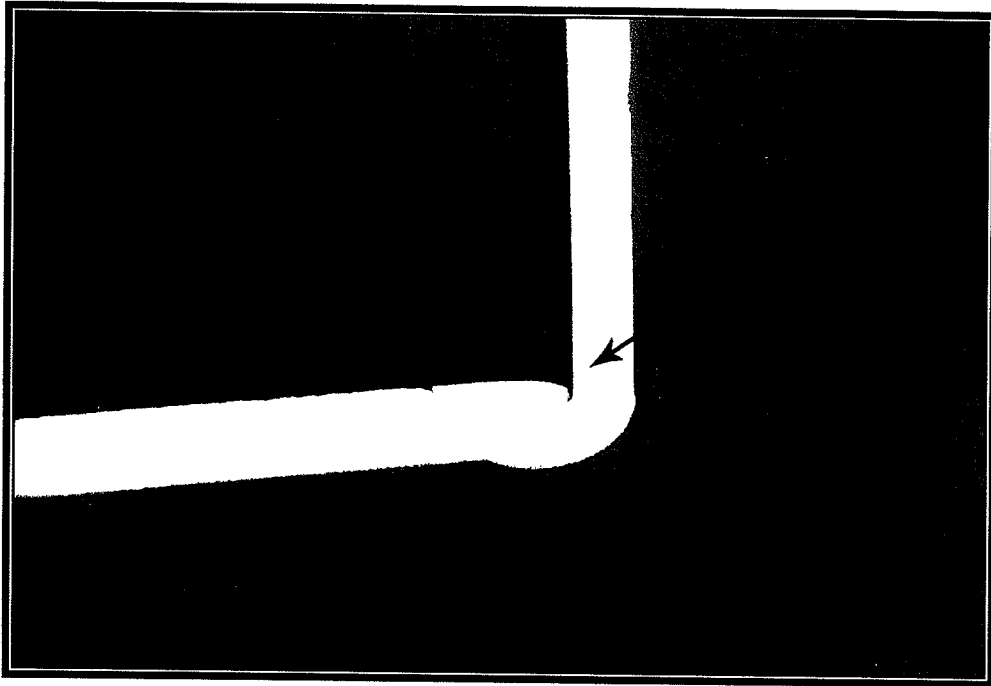
Figure 7 – Photograph of weld cross section IIC, quadrant three, showing some lack of penetration (arrow).

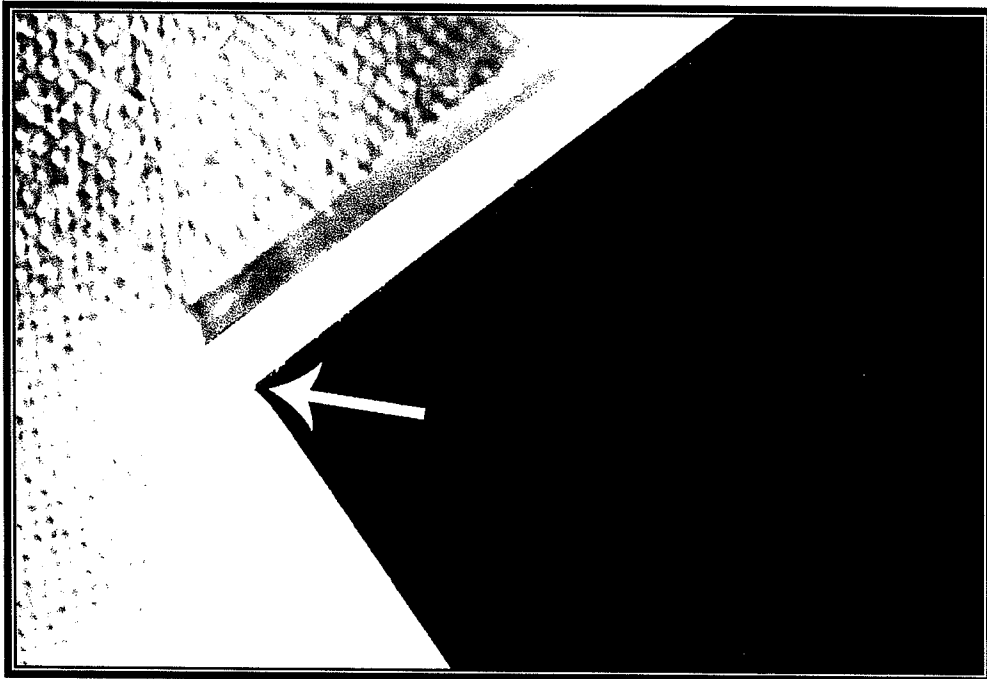
Further sectioning was done on specimens IIIA and IIIB. The areas sectioned and the resulting weld cross sections are shown in Figures 9, 10, 11 and 12. Both of these weld areas exhibit very minor lack of penetration. Again, the significance of this discontinuity is difficult to assess based on visual inspection.

Figure 12 – Slight lack of penetration observed in III B, quadrant three (arrow).
